# STS-117/13A FD 06 Execute Package

MSG	Page(s)	Title
033A	1 - 12	FD06 Flight Plan Revision (pdf)
034	13	FD06 Mission Summary (pdf)
035	14	FD06 Transfer Message (pdf)
037	15	EMU Water Recharge Troubleshooting for Post EVA 2 (pdf)
038	16 - 18	EVA Assessment of OMS Pod Blanket Repair (pdf)
039	19	2B SAW Retract Lighting Information (pdf)
036		FD05 MMT Summary (pdf - Electronic Only)

#### MSG 038 (15-0417) - EVA ASSESSMENT OF OMS POD BLANKET REPAIR Page 1 of 3

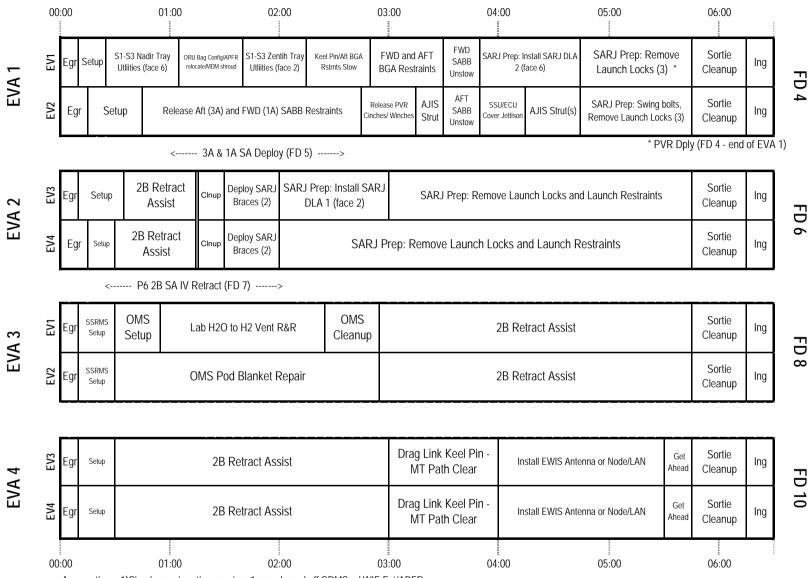
(Option 1 - Early EVA 3 OMS Pod Blanket Repair)

#### STS-117 ISS-13A EVA Timelines

Assumptions: 1)Simple repair option requires 1 crew based off SRMS w/ WIF Ext/APFR

Discussion points: 1)If repair is a single person task, want other EV crew to do productive work. The Lab Vent is the highest priority single person task. JR is better trained for this than Danny. Therefore Danny should do repair. 2)Makes sense for SRMS ingress to be somewhere on Lab fwd. 3)Good possibility that 2B could be completely retracted on EVA 3 in which case time for get aheads on EVA 4 increases.

The following EVA summary timelines illustrate the two options that are under consideration for the OMS Pod blanket repair.

1) Repair at the beginning of EVA 3 2)

Both timelines assume the repair technique can be accomplished by a single crewmember working off the SRMS using the PAD, WIF Extender, and APFR. The leading repair technique involves using a surgical stapler to insert staples between the two blankets at two levels (one between the blankets at a buried layer and the other along the surface) with Saffil pins (designed for use with a Tile Overlay repair) staked from the blanket into the adjacent tiles. The secondary method involves stitching one side of the raised blanket to the surrounding blanket (using an IVA EMU Lacing tool, IVA stainless steel thread, and an IVA dental punch tool), and staking with the Saffil pins. The specific task time required for the repair is still under assessment, but it appears feasible to complete the task in the times allotted in either option.

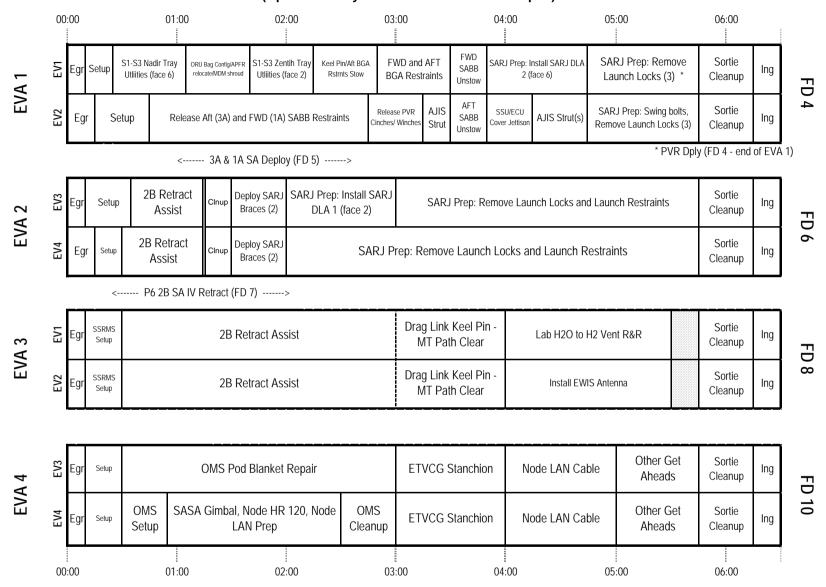
(Option 2 - Early EVA 4 OMS Pod Blanket Repair)

#### **STS-117 ISS-13A EVA Timelines**

This option preserves EVA 1, 2, and 3 as written. Preserves a conservative 2:30 for repair. Free floater tasks during repair are lower priority so it would be lower impact to have him assist throughout repair. This has the least impact on tool logistics during previous EVAs and allows for better repair technique development

Repair on EVA 4

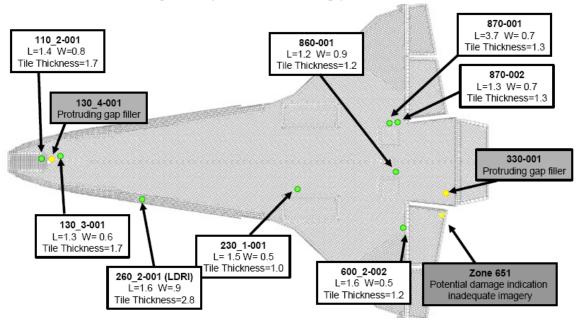
- · Cleared damage sites were assessed with Mach 20.6
  - · Remaining work for partial transition due to gap filler & RH inboard Elevon site
